ENVIRONMENTAL MANAGEMENT PRACTICES

4.1 Sanitary, Hazardous, and Radioactive Waste

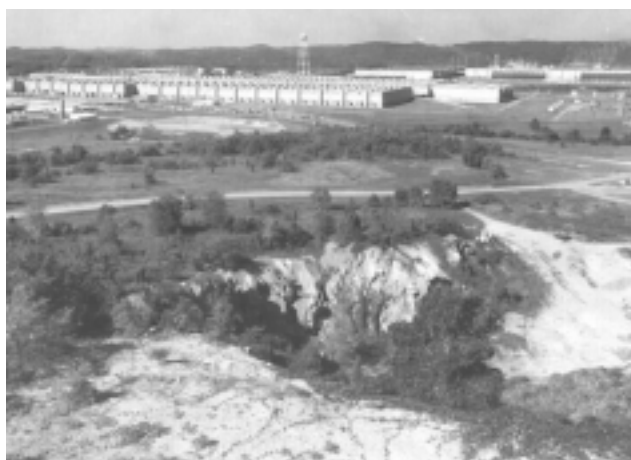
The use of open burning as a disposal method began in 1945 at the K-1099 Blair Road quarry. This quarry received combustible waste, cafeteria waste, lumber, construction waste, electrical equipment, asbestos, oil, and chemicals to be burned or buried. PCB-contaminated waste oils were also likely burned at this site. Additionally, both burial and open burning occurred at the Poplar Creek disposal area (located northeast of the K-1064 peninsula

K-1099 Blair Road Quarry Used for Open Burning of Plant Waste

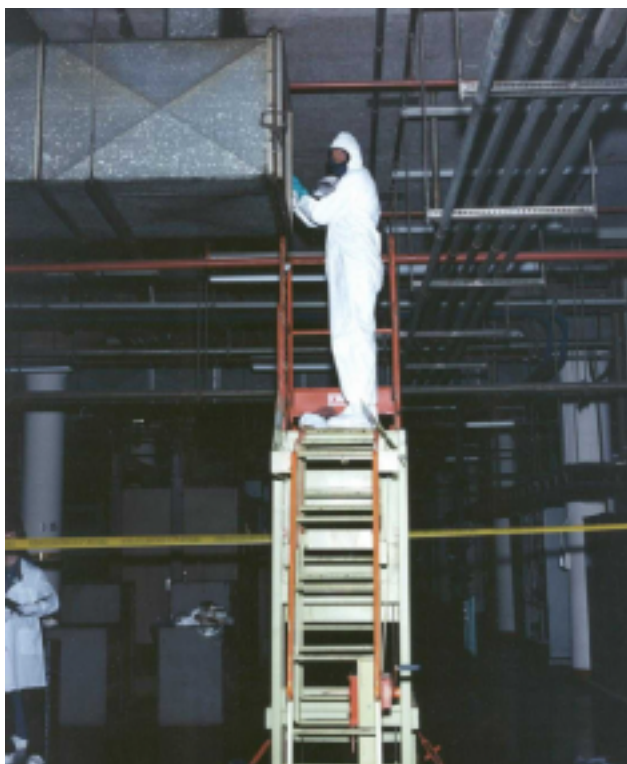
During production, large ventilation ducts were used in the process buildings. Gaskets used in these ventilation ducts were treated with PCBs. Over time, these gaskets became saturated with lubricating oils that dripped out of the gaskets. This oil was radioactive, was contaminated with PCBs, and had to be collected using a trough system. In 1974, actions were being taken to identify PCB equipment and to label transformers. A PCB storage area was established in K-25. In 1977, a PCB program was implemented, followed in 1978 by a formalized waste disposal program. As a result of these efforts, hazardous waste that had been disposed of by discharge into liquid treatment systems, burial, or burning began to be containerized for disposal.

Replacement of PCB Treated Gasket in Process Building

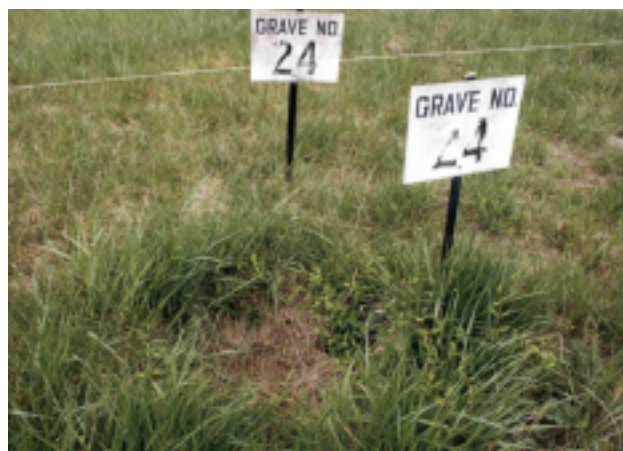
Efforts to segregate and dispose of radioactive wastes generated by Plant activities started in the 1940s. The K-1070-A contaminated burial ground, which operated from the late 1940s until March 1976, was used to bury low-level radioactive waste and mixed waste (i.e., mixtures of radioactive and hazardous chemical wastes). The bulk of the material included uranium-contaminated materials, thorium compounds, contaminated UF₆ cylinders, beryllium chips, boron, and contaminated oily rags. Low-level wastes, such as cleaning rags, scrap paper, and trapping media, were also disposed of in the K-1070-A burial ground. These materials were subsequently sent to Y-12 for disposal after March 1976. In 1976, plans were developed, but never implemented, to remove and transfer the remaining waste to Y-12.

Markers Showing Buried Radioactive Waste in K-1070-A

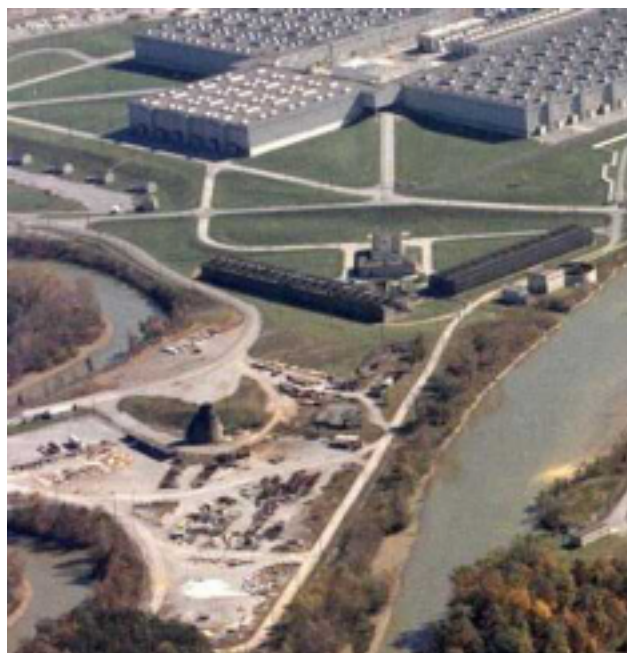
In the 1950s, the K-1064 drum and burn area was used for waste operations and disposal. A large metal structure called a teepee was used to incinerate waste materials, including paints, organic wastes, and radiologically contaminated waste oils. After burning was stopped in 1960, the site was used to store drums containing solvents, organics (including PCBs), and

K-1064 Area's Teepee Used to Incinerate Paints and Contaminated Waste Oils

contaminated waste oil. Radioactively contaminated building debris was also disposed of in this area. Site management learned of this waste area when debris and drums were discovered falling into Poplar Creek in the early 1990s. This area also became a long-term outdoor storage location for radiologically contaminated scrap material, resulting in the spread of radiological contamination to the environment.

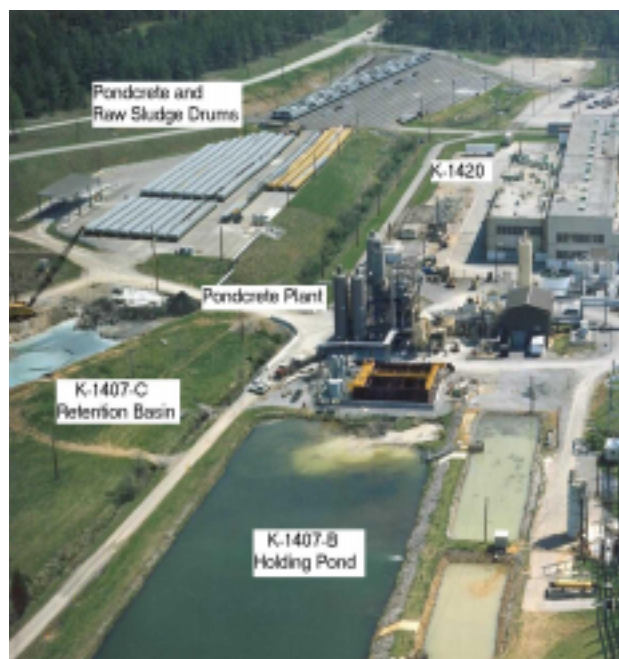
The K-1407-B pond was a receiving body for transuranics at the Plant. The pH conditions in the pond favored chemical precipitation of transuranics; most transuranics settled to the bottom of the pond and were contained in the sludge. When the sludge was removed from the B and C ponds in 1988, it filled approximately 80,000 drums that were then stacked in an area to the east of the C pond. The sludge in these drums was subsequently repackaged as discussed in Section 4.1, and the unit was closed in 1992.

In conjunction with the B pond, the K-1407-C retention basin, or C pond, was built in 1973 for the storage of sludge dredged from the K-1407-B holding pond. The sludge also contained radioactive constituents and corrosive materials. The pond was approximately 300 feet long and 75 feet wide, with a holding capacity of about 2.5 million gallons. The first attempt to characterize the constituents in C pond was conducted in 1984.

K-1407 Holding Pond and Retention Basin

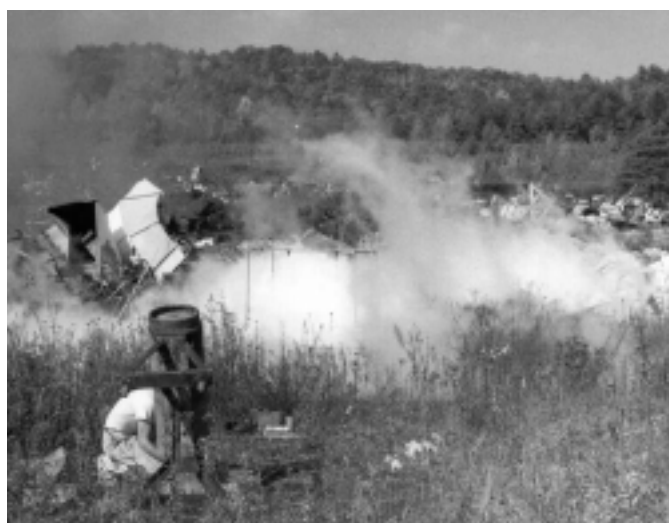
Hydrogen Fluoride Being Released; Note Cylinder and Operator Bottom Left Corner

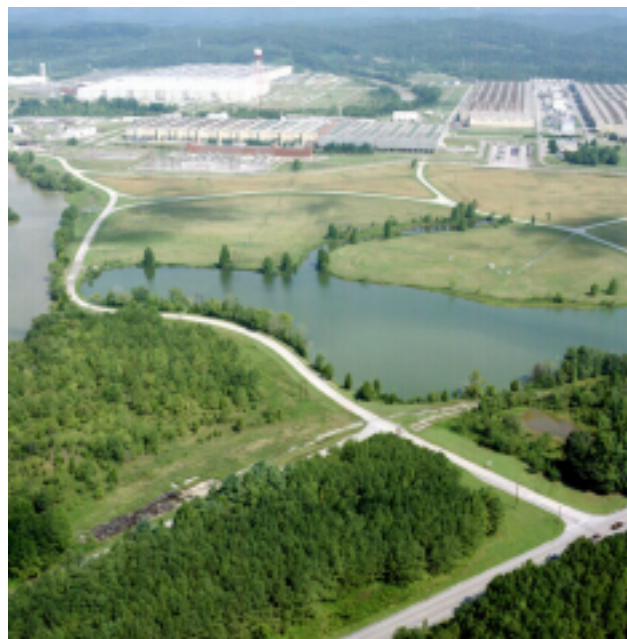
Holding Pond Annually Received 2,200 Gallons of Laboratory Waste Until 1985
